RE: BUSD Corp Yard at 1720 Oregon St: Structural Observations

ZFA conducted a site walk on November 8, 2021 and November 19, 2021 to conduct visual observations of the structures at Berkeley Unified School Districts' (BUSD) Corp Yard located at 1720 Oregon St. ZFA was contracted to provide visual observations of structural material degradation and provide conceptual recommendations for remediation or repair, and consider any applicable code triggers.

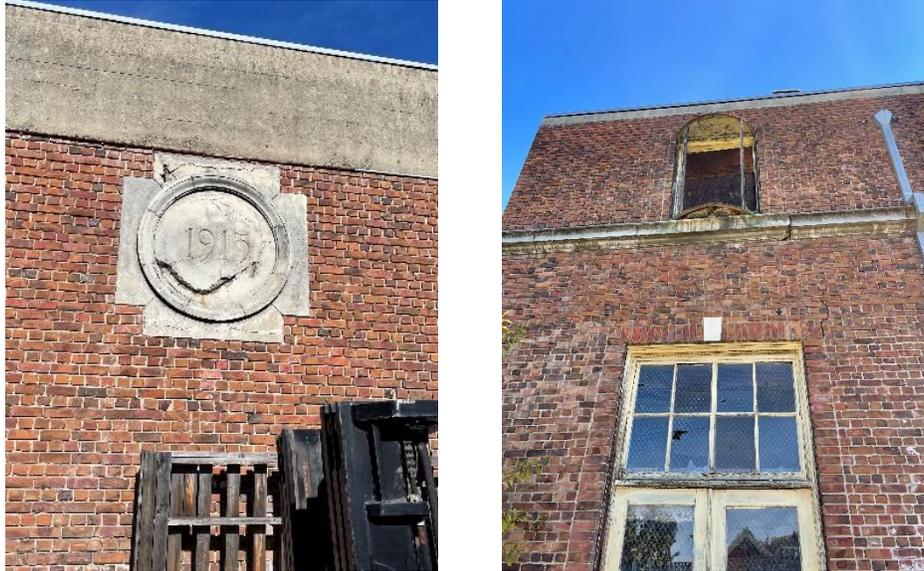
Both of these 1915 structures are formed of Unreinforced Masonry (URM) bearing walls, see Figure 2. This is also observed in the Facility Condition Assessment (FCA) by EMB Group dated October 23, 2018. The structures have wood-framed floors and roofs, and interior wood-framed walls. They were constructed as Edison Junior High School and used as such until 1933 when the Field Act was enacted. The Field Act, formally known as the Safety of Design and Construction of Public School Buildings Act, was California's first major earthquake safety policy. Students were moved out of the building at that time it has since been used for various purposes including housing BUSD's maintenance department.

Figure 2: Photos of the exterior URM bearing walls and the original construction year emblem

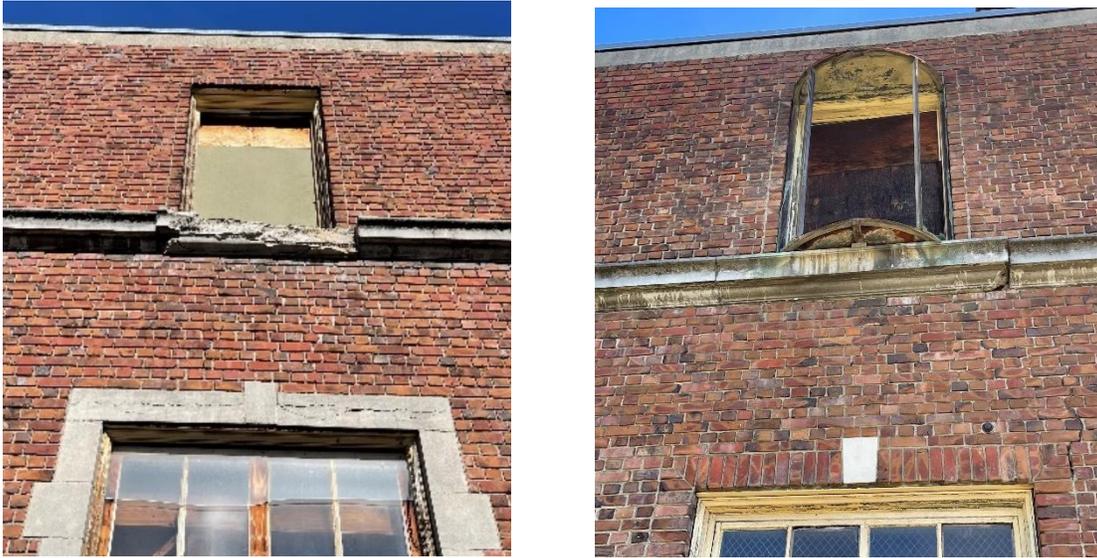
1. **Finding:** Precast elements that are let into the exterior URM walls are cracked and falling, see Figure 5 below.

Figure 5: Photos of cracked and falling precast elements at windows

Recommendation: On site, the hazard was identified, and recommendations were provided to either restrict access to locations subject to falling hazard with a physical barrier or provide plywood shoring over these locations. Further, ZFA recommended removing loose concrete and protect area from water damage until permanent action can be taken. As observed in a subsequent site visit, the loose segments have been removed. While the hazard has temporarily been removed, other precast elements will likely deteriorate and the removal of the precast comprises the exterior envelope, hence the “temporary” status qualifier. We recommend continued monitoring and mitigation of these deteriorating elements until permanent action is taken.

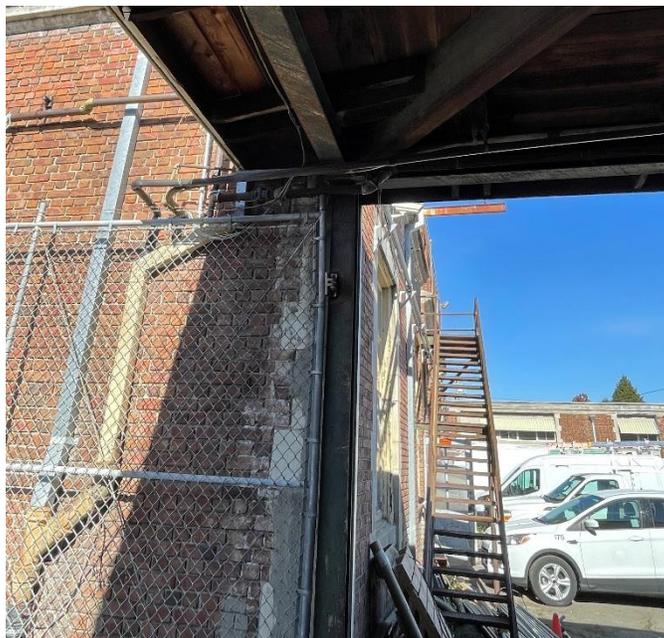
2. **Finding:** The exterior egress stairs at the West Wing on the south side are unstable due to material deterioration and unsafe to walk on.

Figure 6: Exterior egress stairs at the West wing on the South side

Recommendation: Provide barrier restricting access to these stairs/the second floor or provide supplemental support. It is our understanding that this second floor space is not used often, so we do not expect that restricting access will have operational effects. Additional wood framing supports were observed in a subsequent site visit; hazard has been temporarily mitigated.

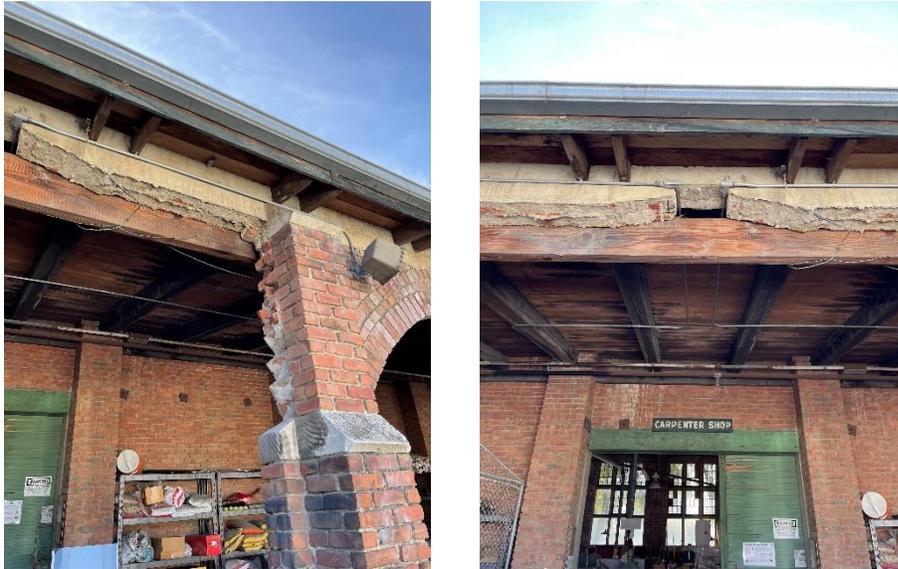
3. **Finding:** At the access door to the carpenter shop, there is an opening which used to have a brick arch. This arch was removed, but the concrete bond beam was left hanging, see Figure 7.

Figure 7: Remaining concrete bond beam at removed arch at Carpenter Shop entrance

Recommendation: While not an imminent hazard, this is a structural concern. It needs to be determined if the arch is historic and needs to be replaced, or if the structure can remain without the arch. If remaining in the current condition is architecturally and historically acceptable, the gravity loading to the bond beam will be analyzed and it is likely that a replacement concrete or steel beam will be provided. Therefore, there is no imminent hazard but there is a created structural deficiency that should be corrected.

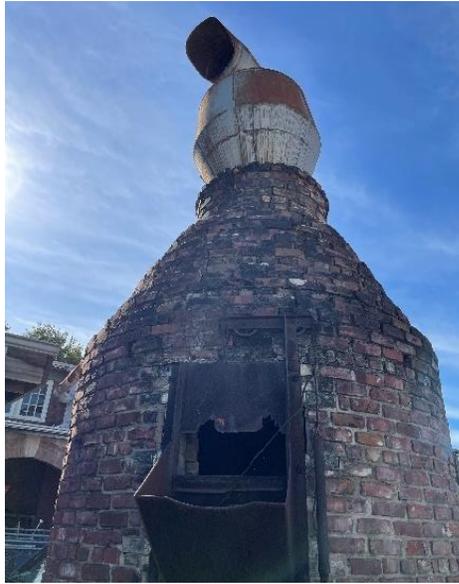
4. **Finding:** The historic furnace is used now used as an exhaust point, see Figure 8. When air blows through, it vibrates the brick structure. This brick structure has extensive and structurally significant cracks – it is structurally compromised and ongoing use will lead this to become an imminent hazard.

Figure 8: Historic furnace

Recommendation: This furnace is located in an accessible area of the courtyard adjacent to regularly used parking. Due to extensive cracking, the URM will eventually pose an imminent falling hazard. If furnace is to remain for historic purposes, the brick walls will need to be repointed and mortar replaced, fixing the bricks. More importantly, provide a steel or concrete structure on the brick's interior (possibly exterior if permitted) to reliably support the structure.

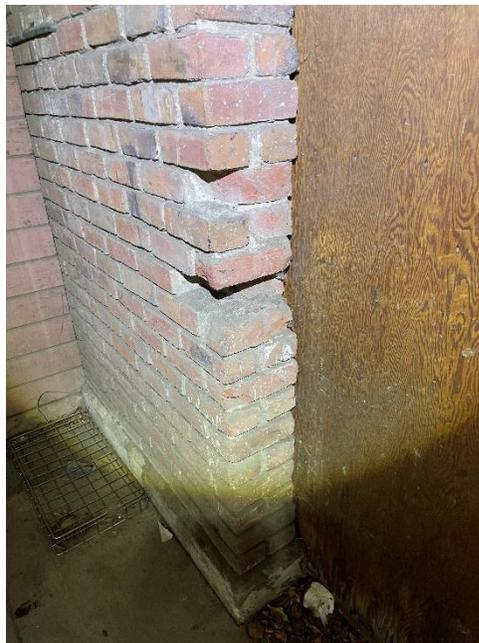
5. **Finding:** Door jamb has localized damage: missing bricks and damaged mortar.

Figure 9: Localized damage at existing door jamb

Recommendation: This is not an imminent hazard but serves as further evidence of the URM's deterioration. During future building work, fix this and several other localized damaged areas.

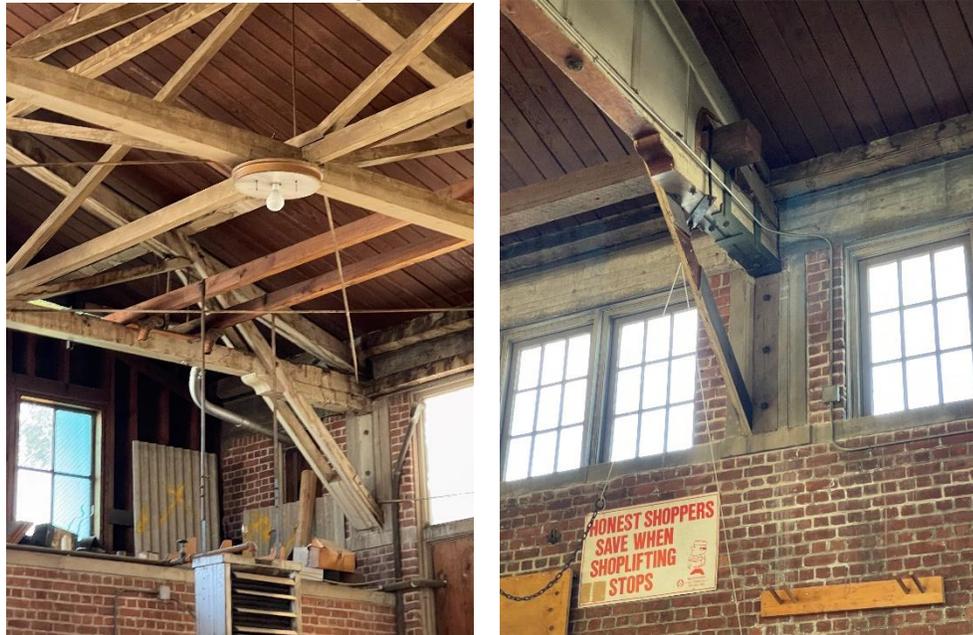
6. **Finding:** In the main workshop area of 107 Russel St, one of the supporting diagonals of one of the trusses was cut, see Figure 10.

Figure 10: Missing truss diagonal shown in on the right, and truss with both diagonals on the left

Recommendation: Replace the removed supporting diagonal in kind. However, this will need to be coordinated with other mandatory strengthening requirements, as discussed later.

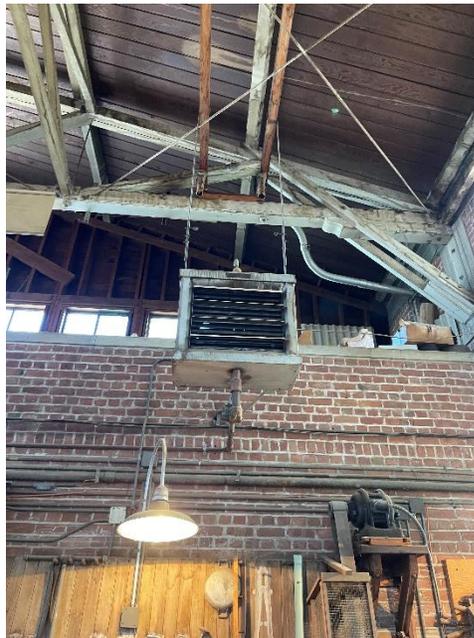
7. **Finding:** There is an aged heater hanging over a work area in the main workshop area, see Figure 11.

Figure 11: Unbraced hanging heater at the main workshop area

Recommendation: Remove the heater if it's not functional, otherwise brace as part of the mandatory upgrade requirements/best practices. Bracing to likely include either Unistrut or cable bracing and hangers.

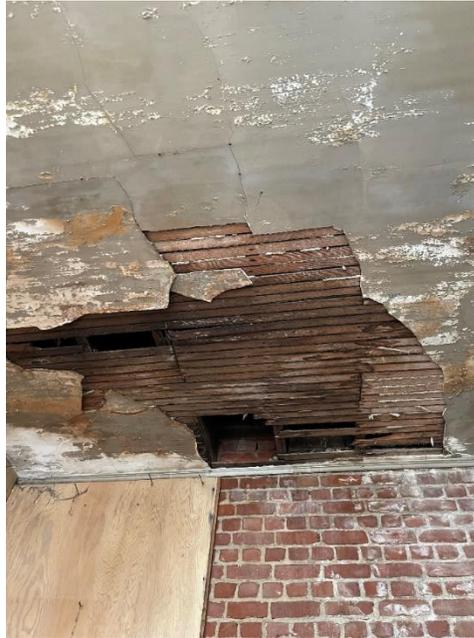
8. **Finding:** There is evidence of extensive water damage in all buildings, see Figure 12 and 13.

Figure 12: Water damage at ceiling

Recommendation: Identify and remedy the source of the water leak. Remove existing finishes and any damaged structural members and replace in kind. Engage an expert to identify interior mold and/or other hazardous material issues and provide recommendations for repairs. Coordinate this work with mandatory strengthening requirements discussed later.

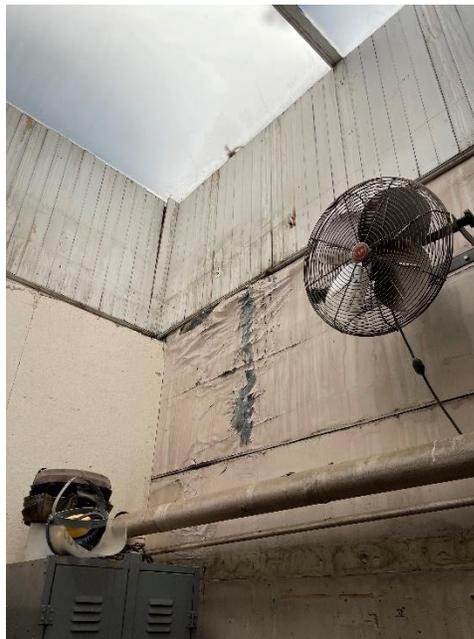
Figure 13: Evidence of water damage and peeling paint

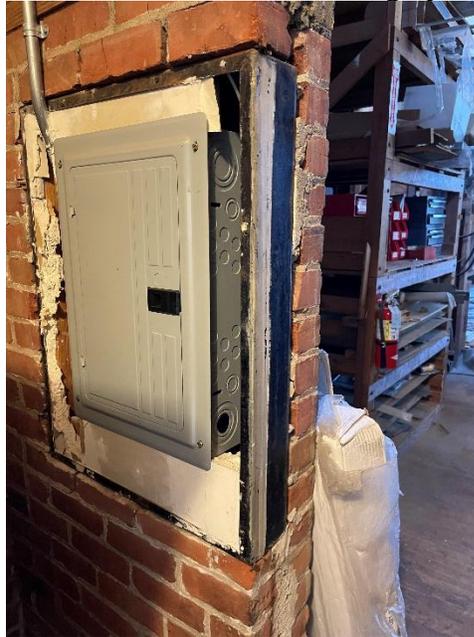
9. **Finding:** There is an electrical box directly adjacent to an opening in a structural URM wall, see Figure 14. This is an example of several created structural deficiencies not

permitted by code. Other items include penetrations created in basement walls that are not reinforced and compromise the wall's structural integrity.

Figure 14: Electrical box immediately adjacent to opening in URM wall

Recommendation: This electrical box was inset into an existing URM wall, making that wall too thin to be able to span from floor to roof framing in the out-of-plane direction. While not more of an imminent hazard than the entire building being URM, this is a structural deficiency and should be addressed in future work on the building. Again, coordinate with mandatory strengthening requirements.

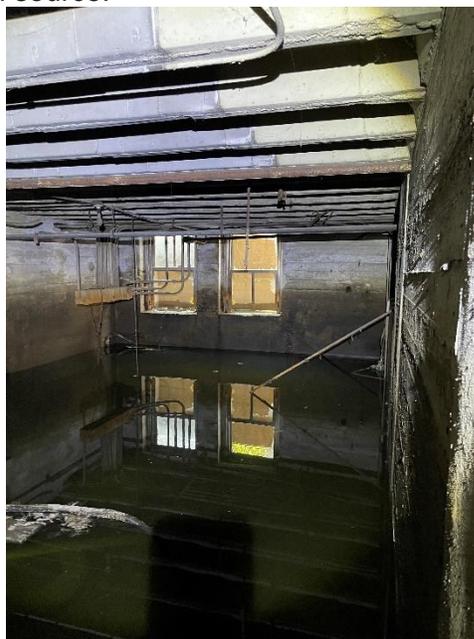
10. Finding: There is significant water ingress from various sources in the subterranean basement, see Figure 15 and 16. This has been an ongoing issue for at least 16 years as the 2005 Assessment notes also that “the basement is not used due to continual flooding from an unknown source.”

Figure 15: Significant water ingress at basement

Recommendation: As this area is not intended for use nor has it been used in over a decade due to longstanding water infiltration issues, we recommend mitigating the water ingress by filling the basement with Cell-Crete (cellular concrete). Cell-crete is an engineered lightweight foam concrete often used for bulk filling of disused subterranean structures and pipes, approaches to bridges and other civil applications. This Cell-Crete would extend to slightly above the elevation of the sill of the window shown in Figure 15 above so that the basement will no longer fill with water. The source of the water should also be considered and investigated as part of any and all civil works at the site.

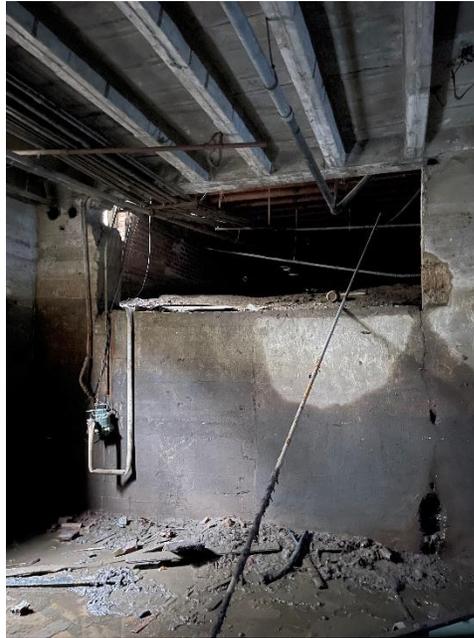
Figure 16: Basement after water drained, previous water level can be seen on concrete basement wall

11. Finding: A large opening was created in the concrete basement wall, see Figure 16 above.

Recommendation: The opening results in a reinforced concrete girder beam above the opening that was not designed for these loads nor does it have appropriate bottom reinforcement. Repair of this created structural deficiency should be coordinated with the mandatory requirements noted below. Wood posts have been installed to support the girder; there is no imminent hazard due to the implementation of temporary supports.

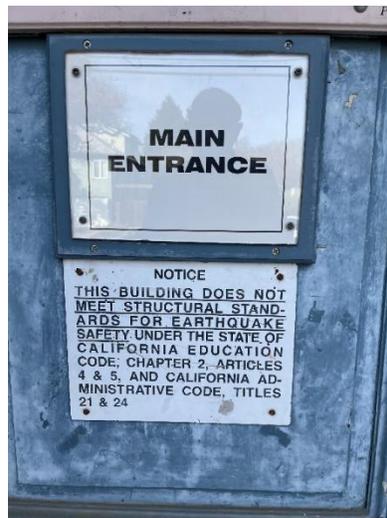
Figure 17: Placard at entrance indicated the building does not meet structural standards for earthquake safety

The subject property fits into category 1. However, it is not currently on the inventory list of URM buildings in Berkeley, which could be an administrative oversight that dates back to 1973 when the building complex was converted from educational to administrative and plant operations functions and moved from under the Division of State Architecture (DSA) to the local (City of Berkeley) jurisdiction. In Chapter 19.38, it explicitly states that the “inventory shall be maintained and revised as necessary by the building official,” so should the building official become aware of this URM building, we would expect it to become a member of the inventory and thus subject to the provisions of this chapter. Additionally, as it stands, even if the building official decides not to add the structure, URM buildings are known to pose a significant life safety hazard in the event of an earthquake and have a strong likelihood of failing, so structural retrofit is best practice. Subject to verification of these findings, due to the building’s condition and the URM hazard, **this building does not meet current code and should not be occupied.**
